JOINT PERMIT APPLICATION

MARCH 12, 2014

The James River Water Authority submits this Joint Permit Application Package for a new water withdrawal to be located near the Town of Columbia. This withdrawal permit will replace the existing VWP Individual Permit Number 04-0805, dated June 12, 2006 for a withdrawal at Bremono Bluff.

JAMES RIVER WATER AUTHORITY
PRELIMINARY JURISDICTIONAL WATERS OF THE U.S.
DELINEATION PACKAGE

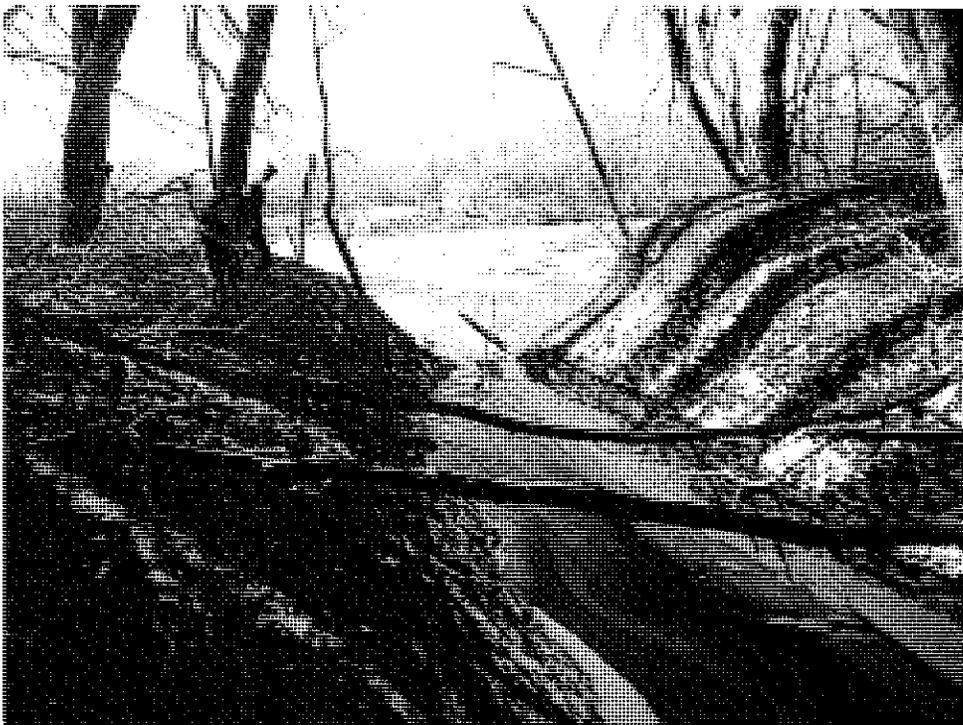
Unserviced perennial stream as it flows into the James River. (1/30/2014, E. Wirtz)

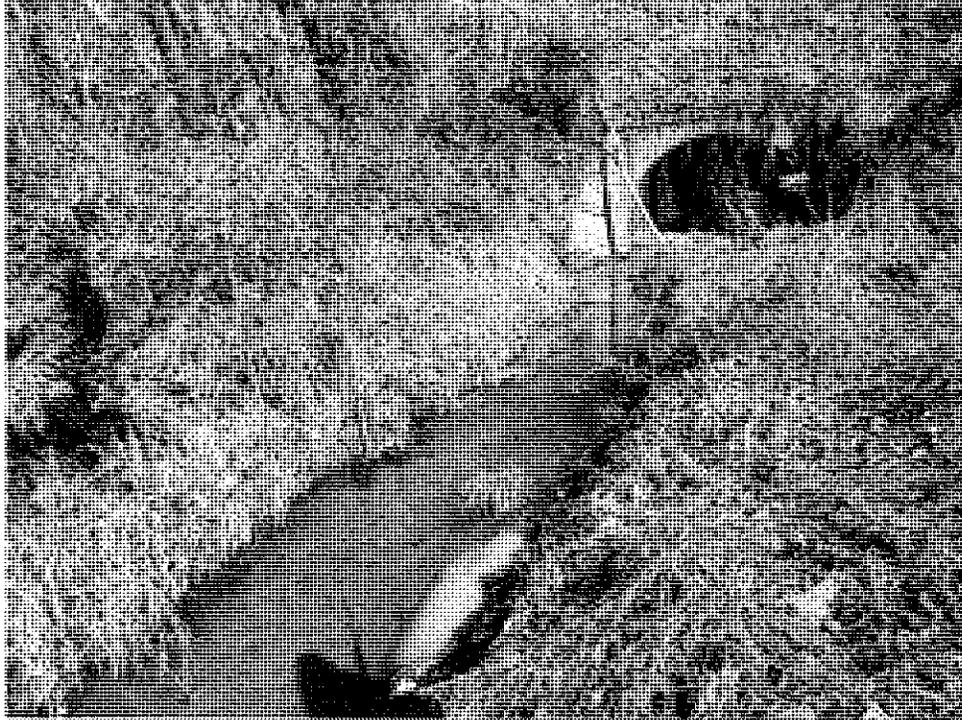
Stream as it exits a culvert under State Route 6. (1/30/2014, E. Virts)

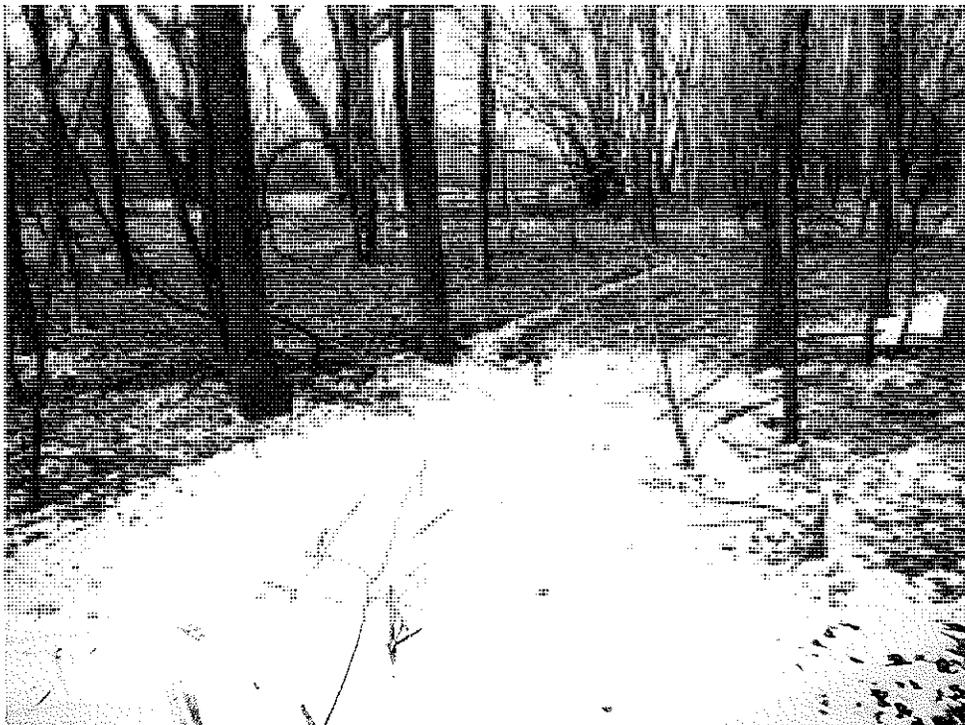
A depression at FDS Q-1 that has pooled water but lacks hydric soils. (1/31/2014, E. Virts)

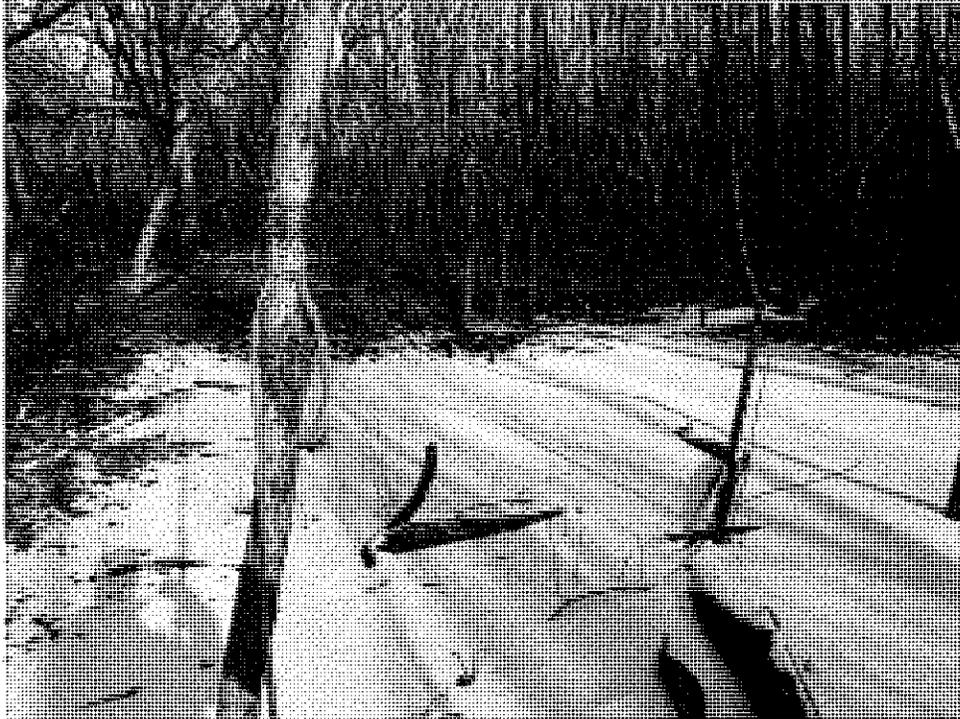
Wetland located at FDS Q-2. (1/31/2014, E. Virts)

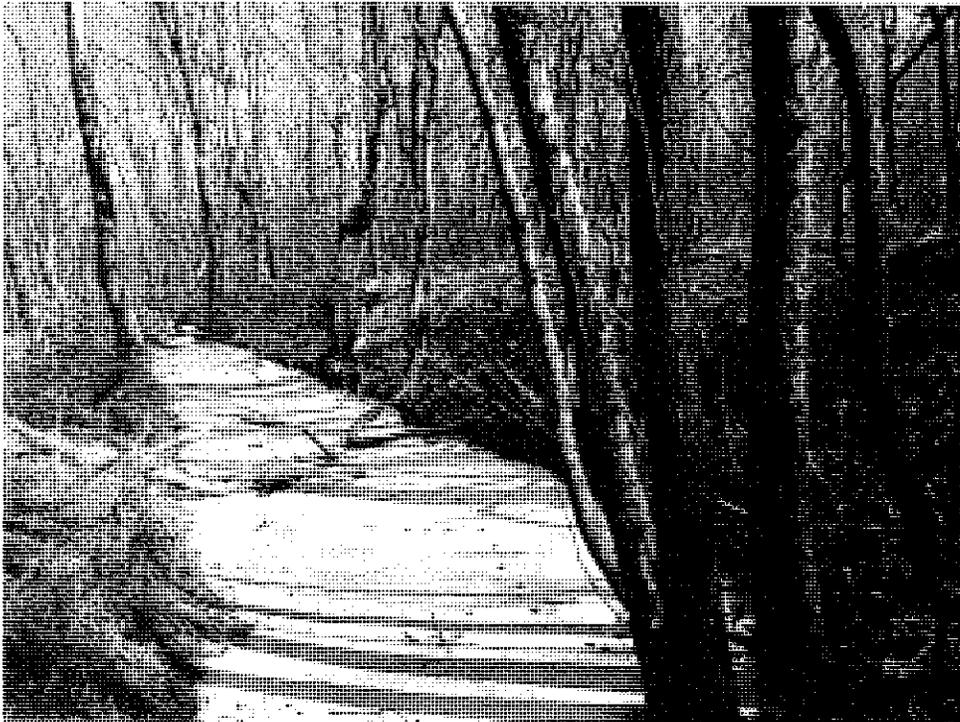
Linear wetland that runs parallel to a historic railroad grade. (1/31/2014, E. Virts)

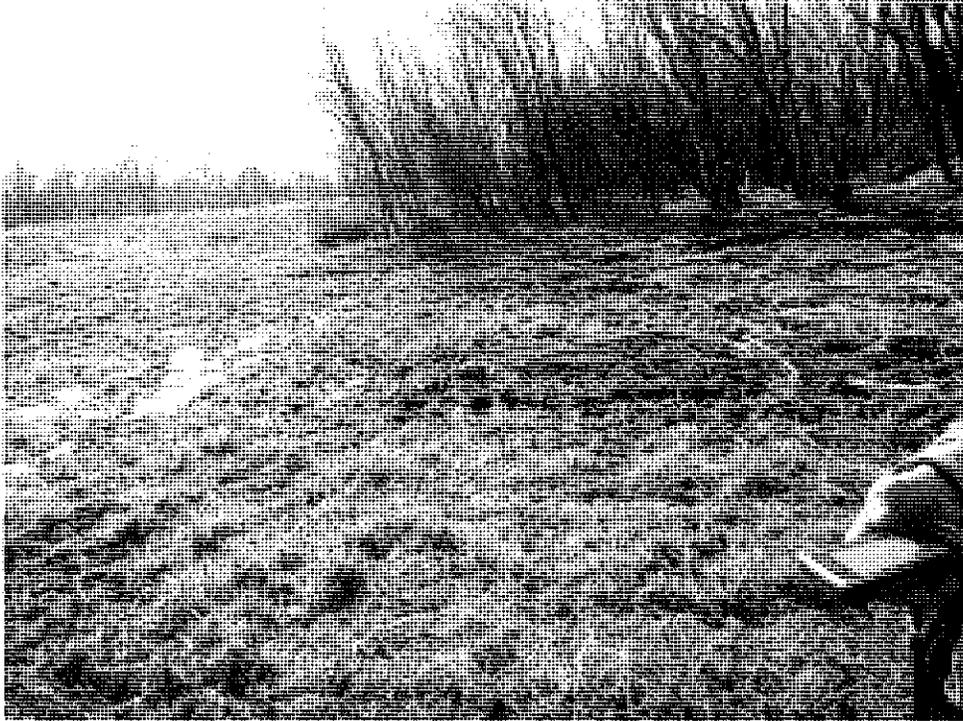
Wetland that is located within a power-line easement. (1/31/2014, E. Vitis)

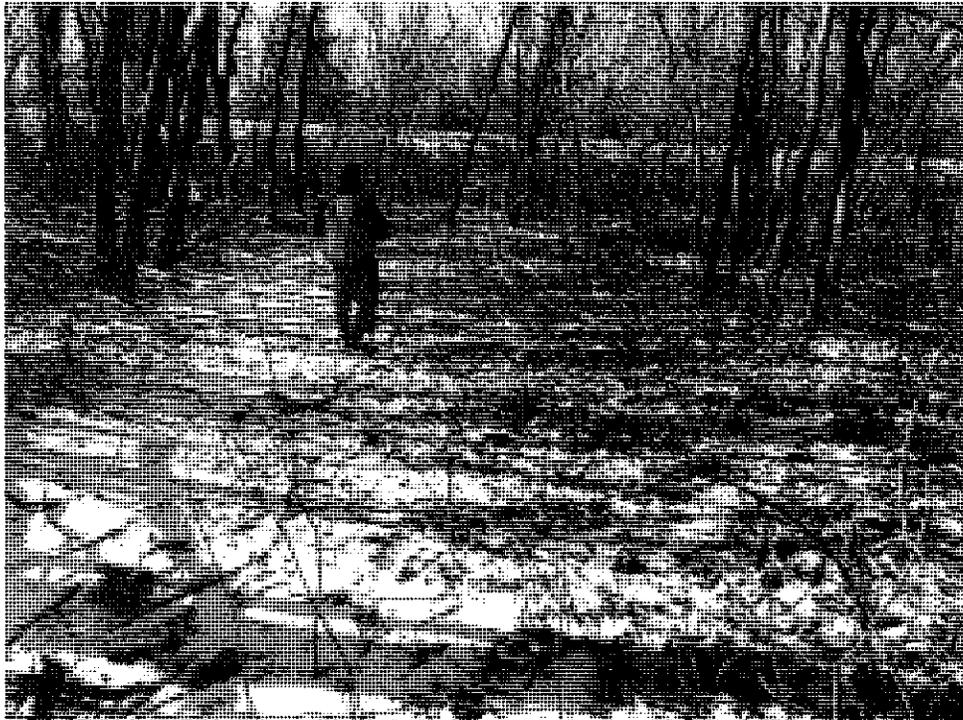
Wetland on the north side of the railroad, adjacent to the town of Columbia. (1/30/2014, M. Hepner)

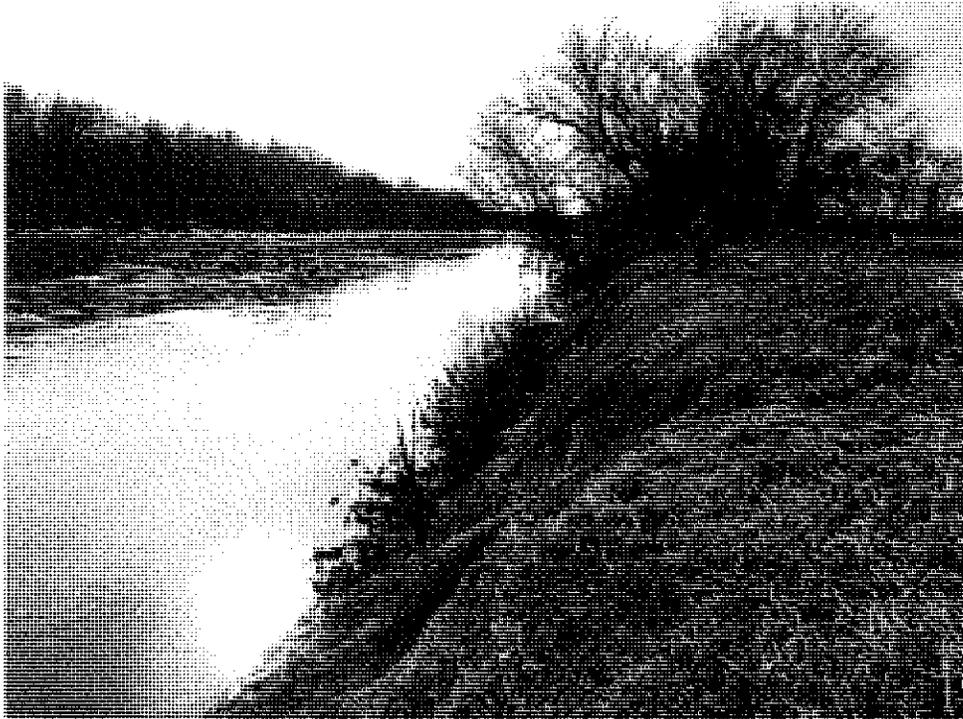
Left bank of the James River facing upstream. (1/31/2014, M. Hapner)
